Preliminary severe event review of April 12, 2008

Damage Survey Report

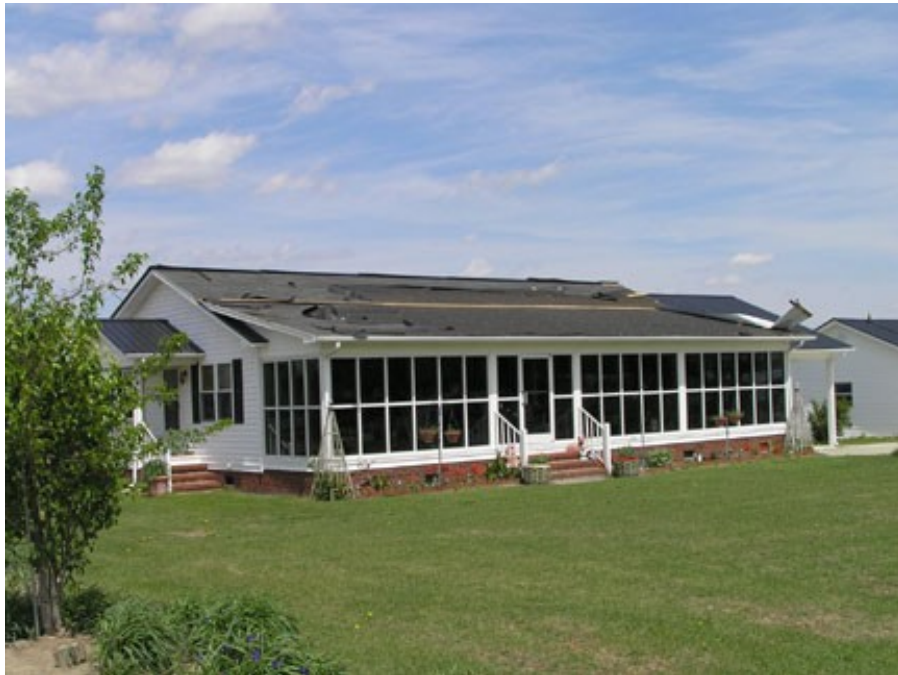
A metal roof is torn off of a resident's house near Chinquapin, NC.

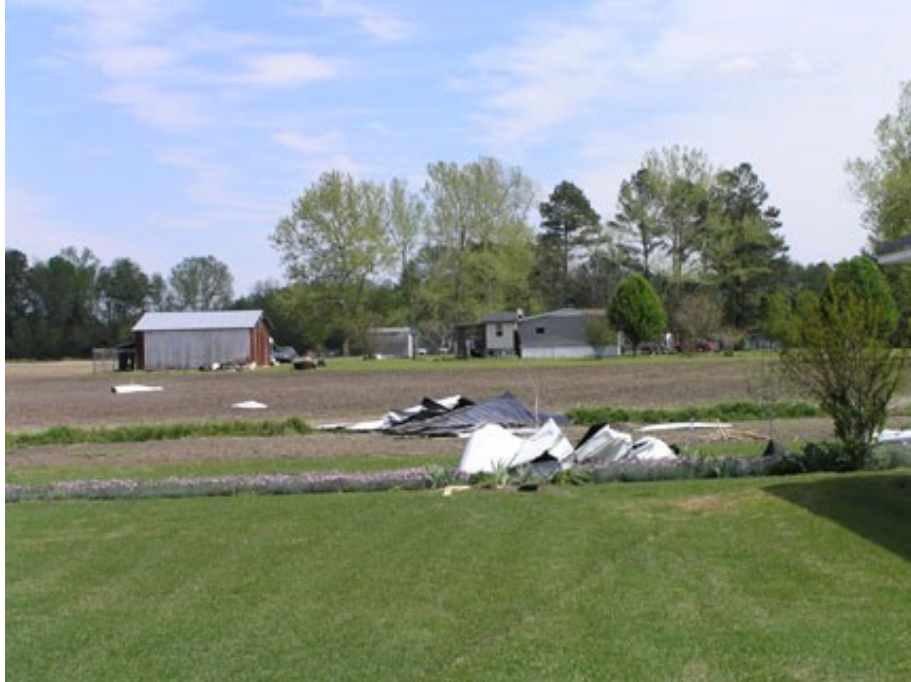
Debris from a resident's roof lies scattered across an open field. The damage occurred near Chinquapin, NC.

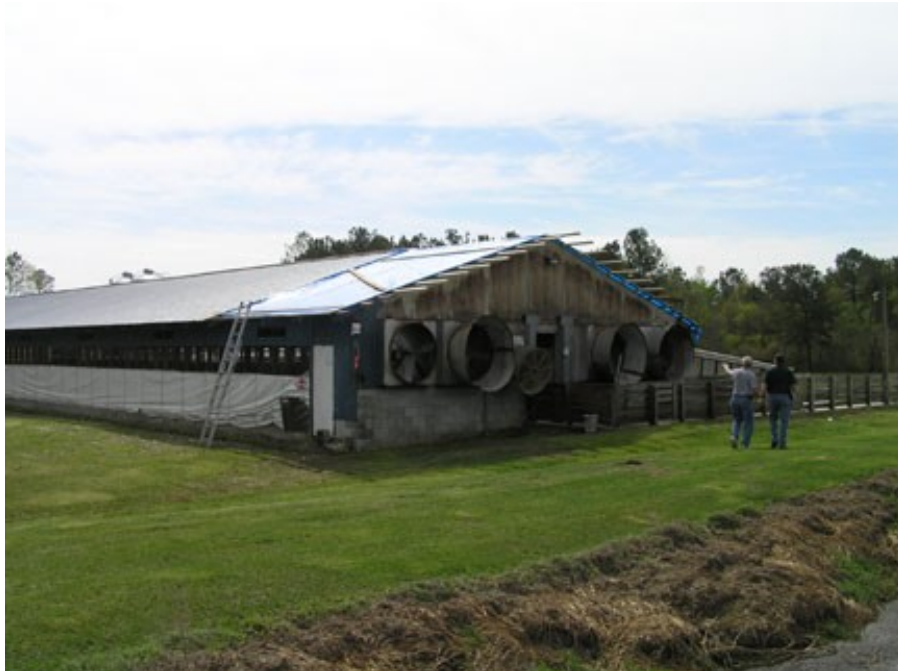
A metal roof of a hog house damaged 5 miles east of Beulaville, NC on HWY 24.

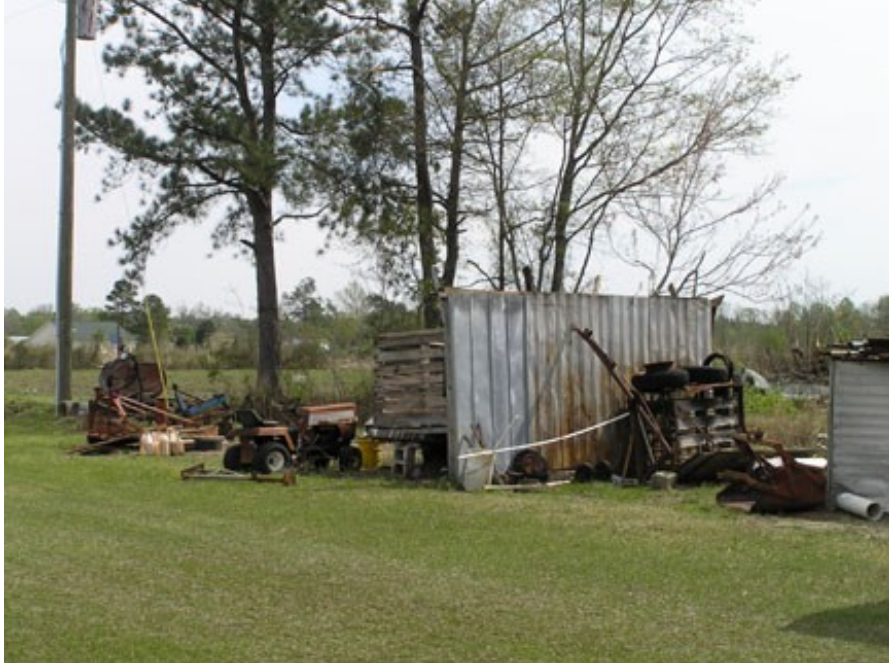
An out-building is destroyed on a hog farm 5 miles east of Beulaville, NC on HWY 24. The garden tractor and wooden wagon was kept inside the once standing structure. Note the one wall still standing.

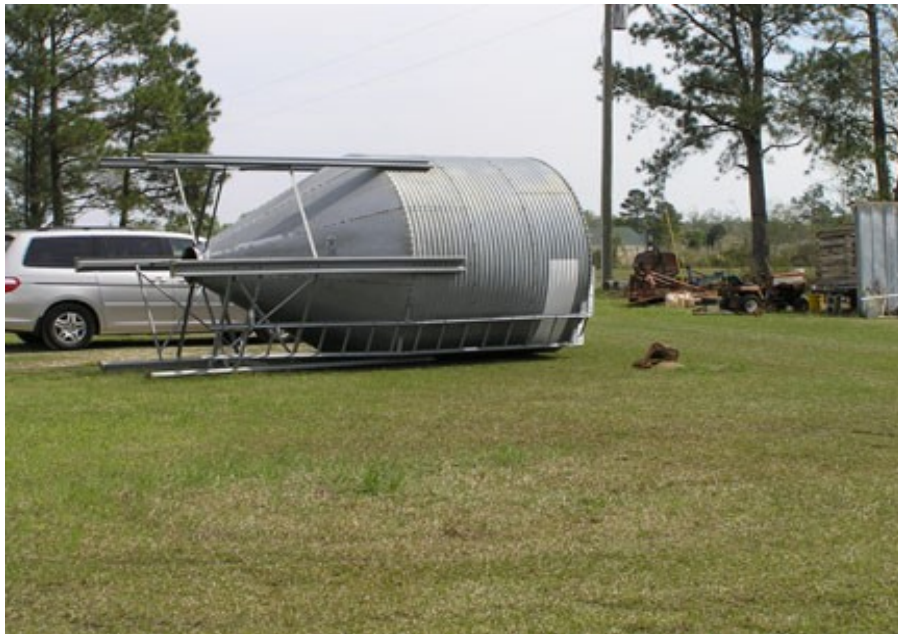
An empty grain bin is shown toppled. The grain bin was located on a hog farm east of Beulaville, NC along HWY 24.

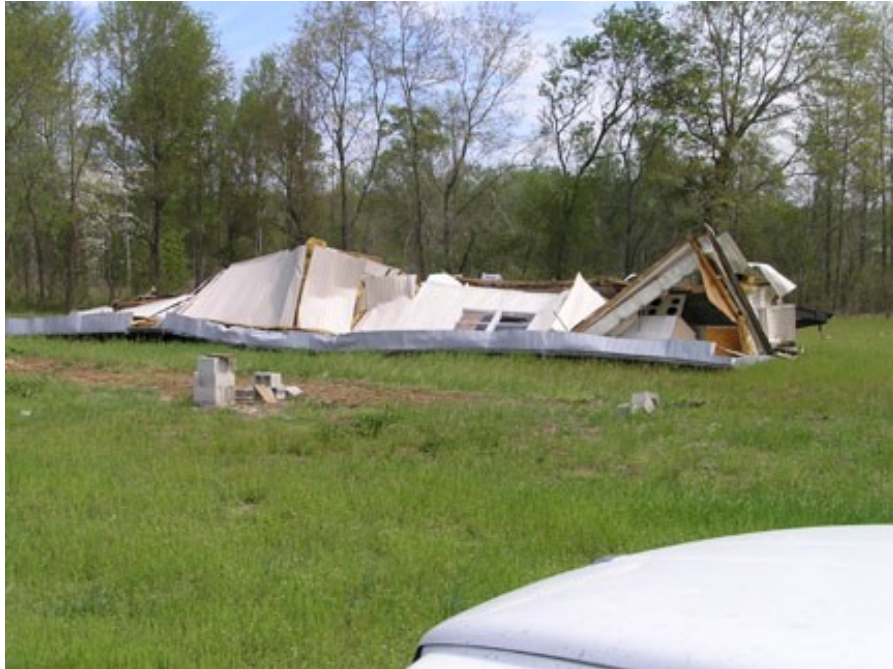
An abandoned mobile home was rolled and flattened along HWY 24 about 6 miles east of Beulaville, NC.

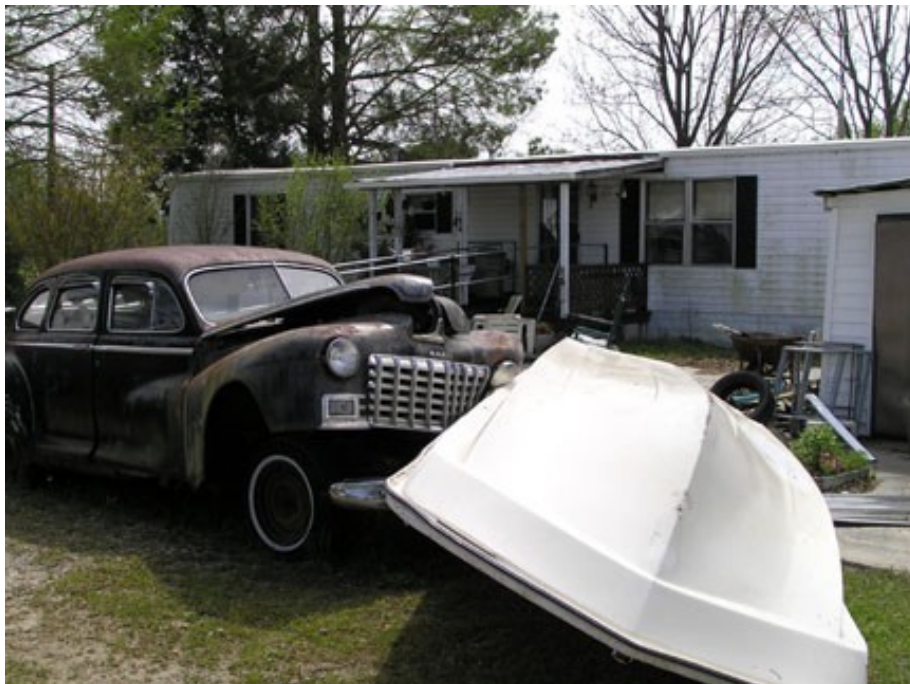
A small fiberglass boat is shown flipped onto an antique automobile. The damage occurred along HWY 24 east of Beulaville.

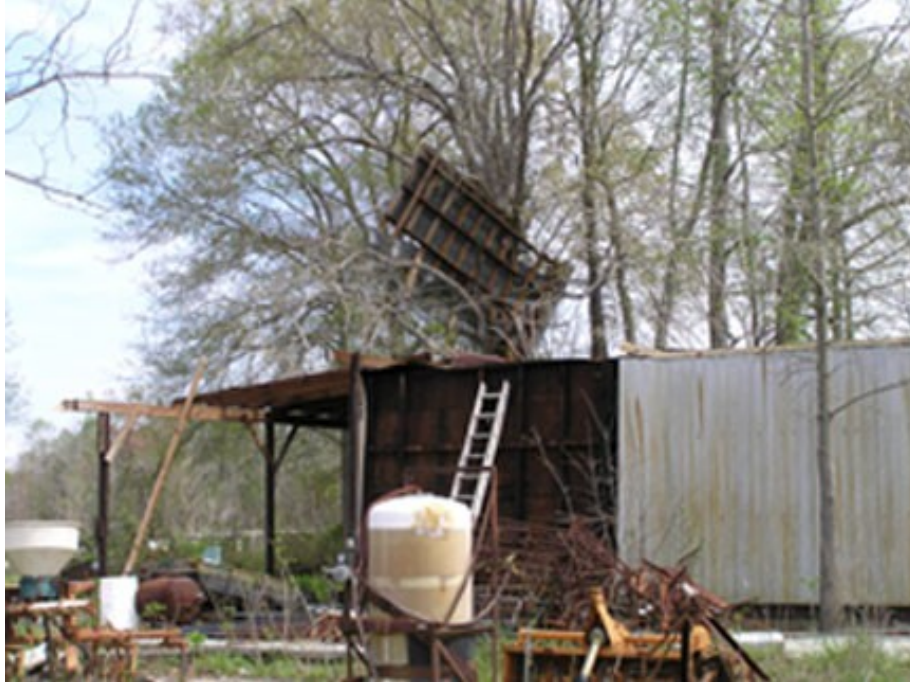
Portion of a metal roof from an out building lies suspended from a tree. The left side of the picture shows extensive damage done to the wood framework of the building. The damage occurred east of Beulaville, NC along HWY 24.

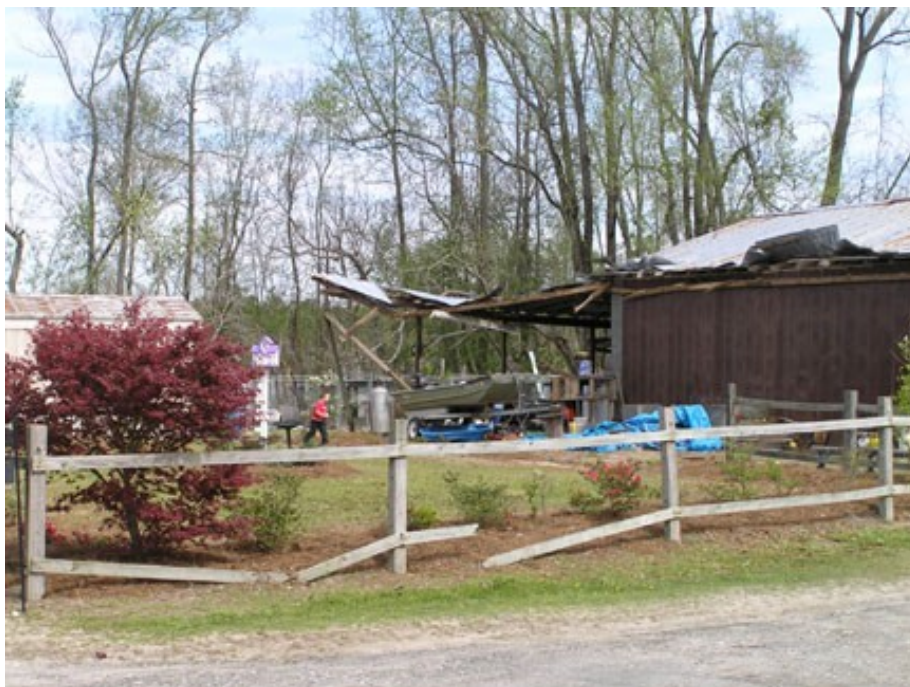
Damage to an out building is visible with the metal roof peeled back. The damage occurred east of Beulaville along HWY 24.
